Spa Ponds Nature Reserve

Site Management Plan

March 2021

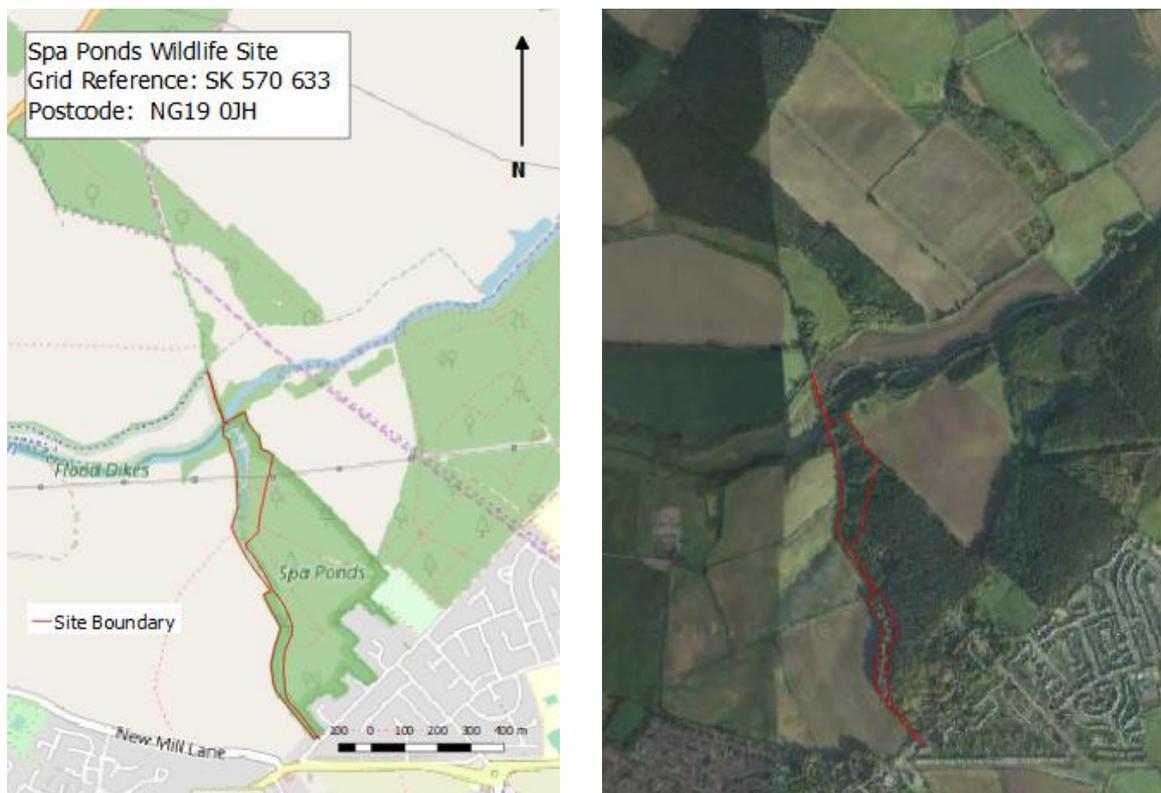
Figures 1a and 1b. Spa Ponds Nature Reserve Map and Aerial View

FTNCG owns the Spa Ponds site, which includes the Spa Ponds Nature Reserve, an area of 4.8 hectares of land highlighted in Figures 1a and 1b, below. Spa Ponds was purchased FTNCG by in May 2014, and in March 2015 the deeds (Title number NT502006) were registered in the name of the Official Custodian for Charities.

Spa Ponds is situated immediately off Clipstone Drive, Forest Town, Mansfield. See above Figures 1a and 1b for Spa Ponds Nature Reserve map and aerial view.

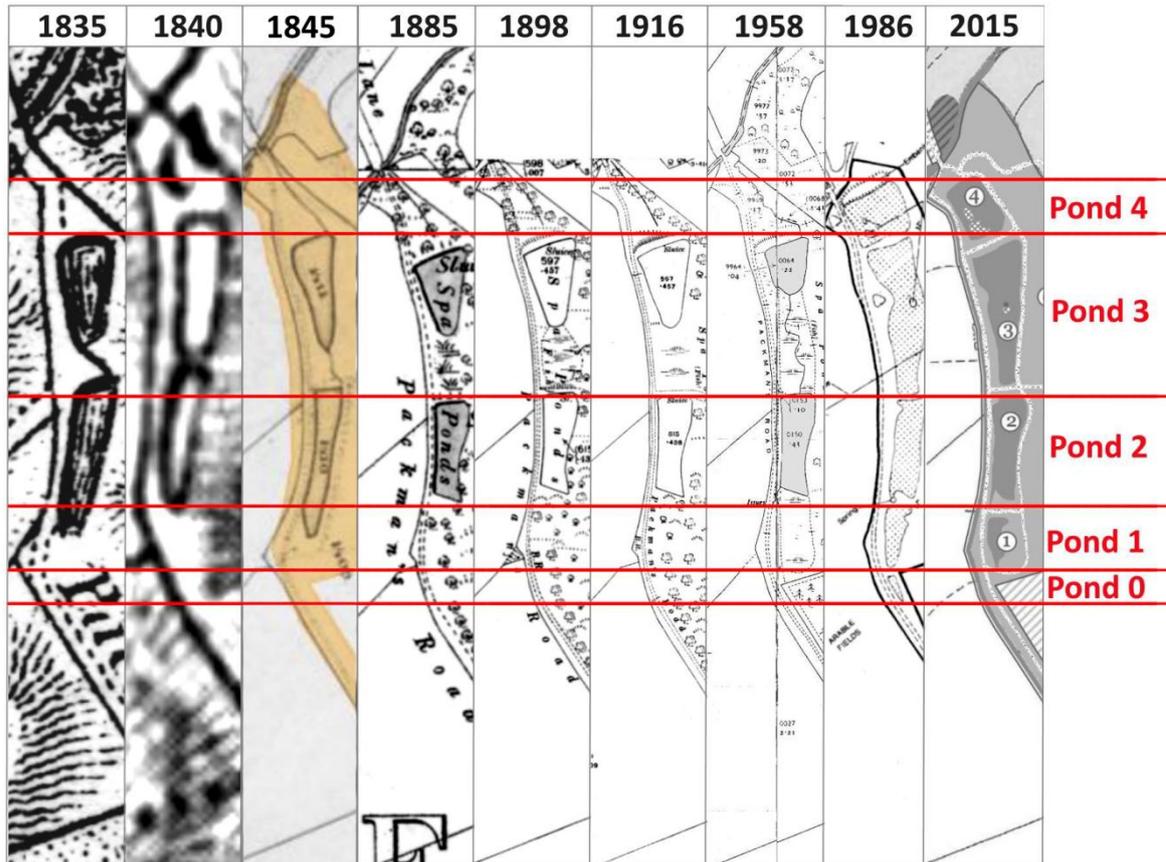
Figure 4. How the Spa Ponds have changed over 180 Years (1835-2015)

The earliest map to clearly show Spa Ponds is Sanderson's Map of 1835, which showed two ponds which are roughly in the same position as those which are now known as Ponds 2 and 3 (with Ponds 1 being the southern-most pond and Pond 4 being the northern-most pond, located nearest to the River Maun). Ordnance Survey (OS) maps indicate that the pond system remained largely unchanged until subsidence in 1983 resulted in the partial re-creation of the ponds, giving rise to the current 4-pond system.

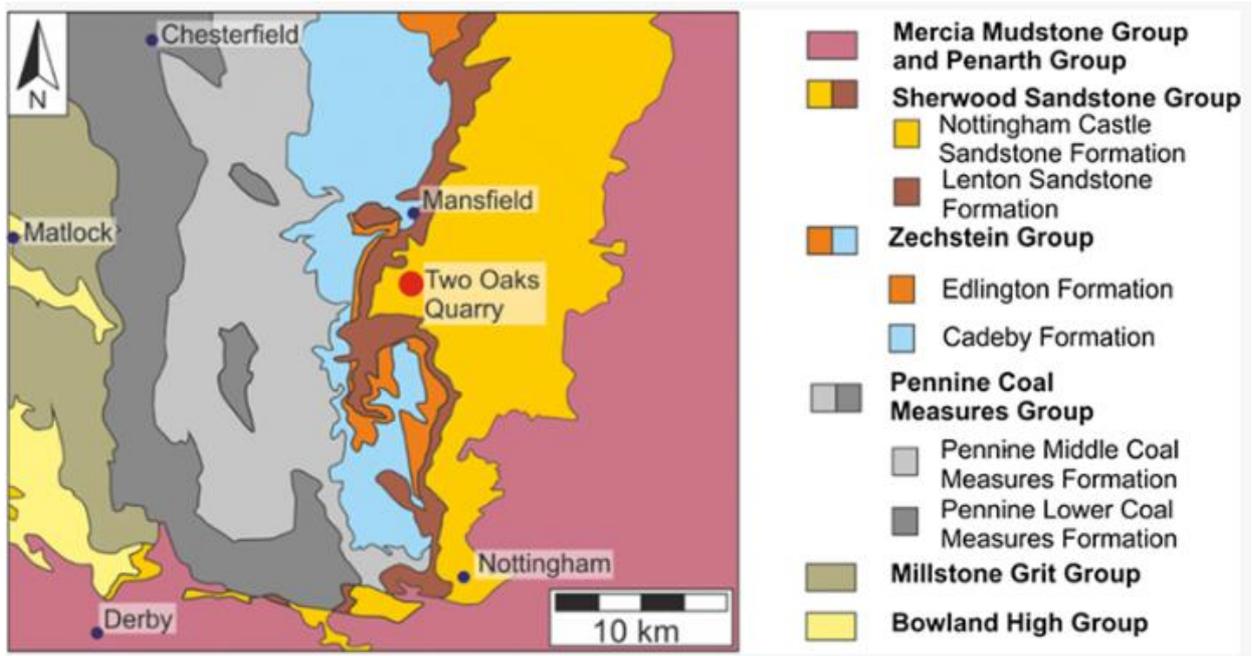
Figure 6. Map showing underlying solid geology (Geotechnical and Geological Engineering, June 2019)

Underlying solid geology is Triassic Nottingham Castle Sandstone Formation (see Figure 6, overleaf). At Spa Ponds, the Bunter Pebble Bed series outcrops in places. The sandstone has produced light sandy loam, which is acidic and free draining.

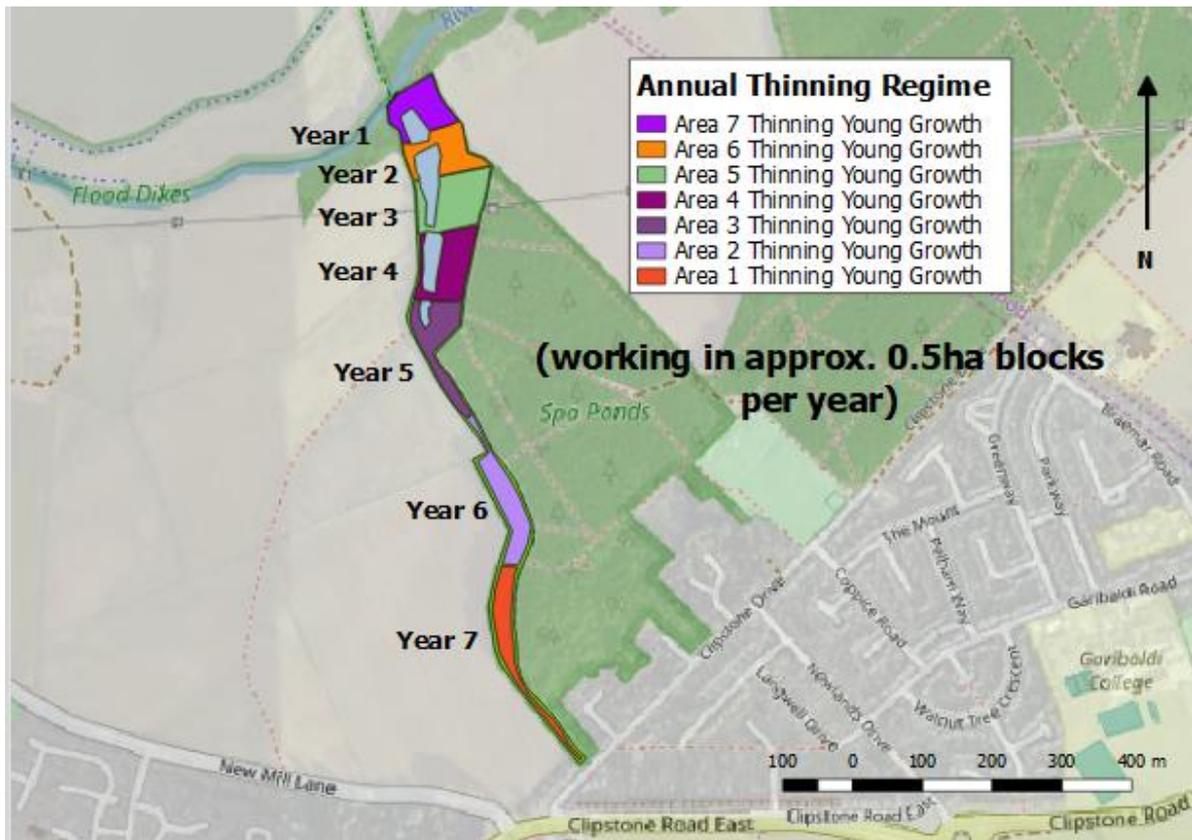
Figure 7. Spa Ponds Woodland Management Map

Woodland edges will be managed as boundary hedgerow and management prescriptions are outlined in section C.2. Selective thinning should be carried out in 7-10 year rotations, working annually within areas approximately 0.50ha as highlighted in Figure 7, above.

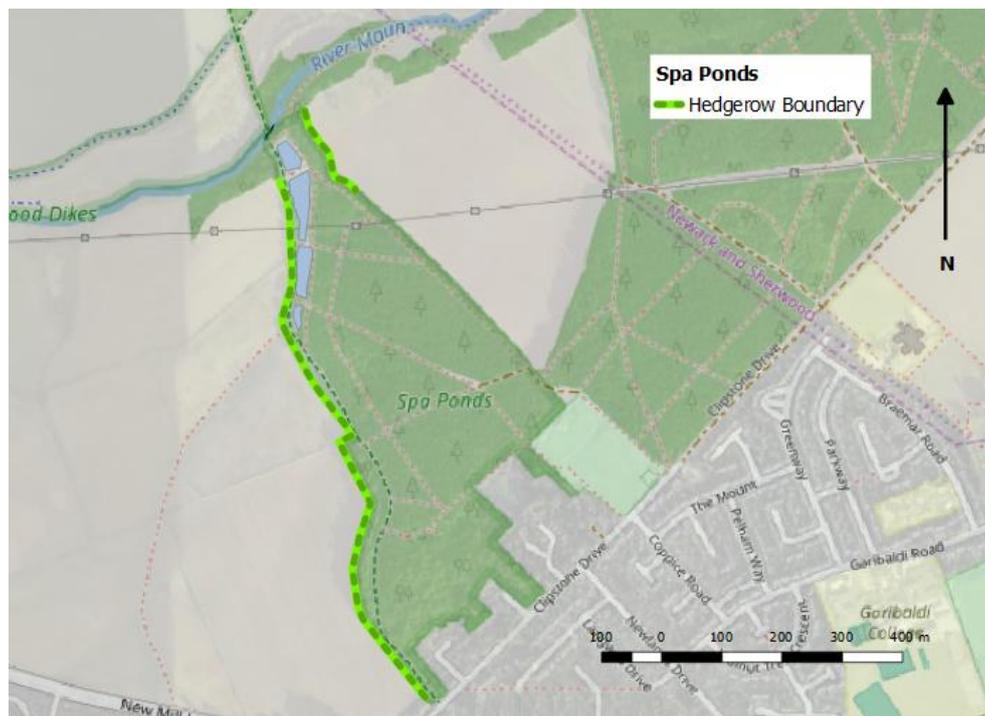
Figure 8a. Hedgerows along the site boundary

Spa Ponds is bordered by 1,150m of boundary hedgerow highlighted in Figure 8a, below. Sections of hedgerow on the woodland edge along the western border of the reserve are in unfavourable condition. Hedgerow structure needs to be restored and sustainably maintained for improved biodiversity value. Use brush from any woodland thinning to create dead hedge in areas where there are 'gaps' in the hedgerow.

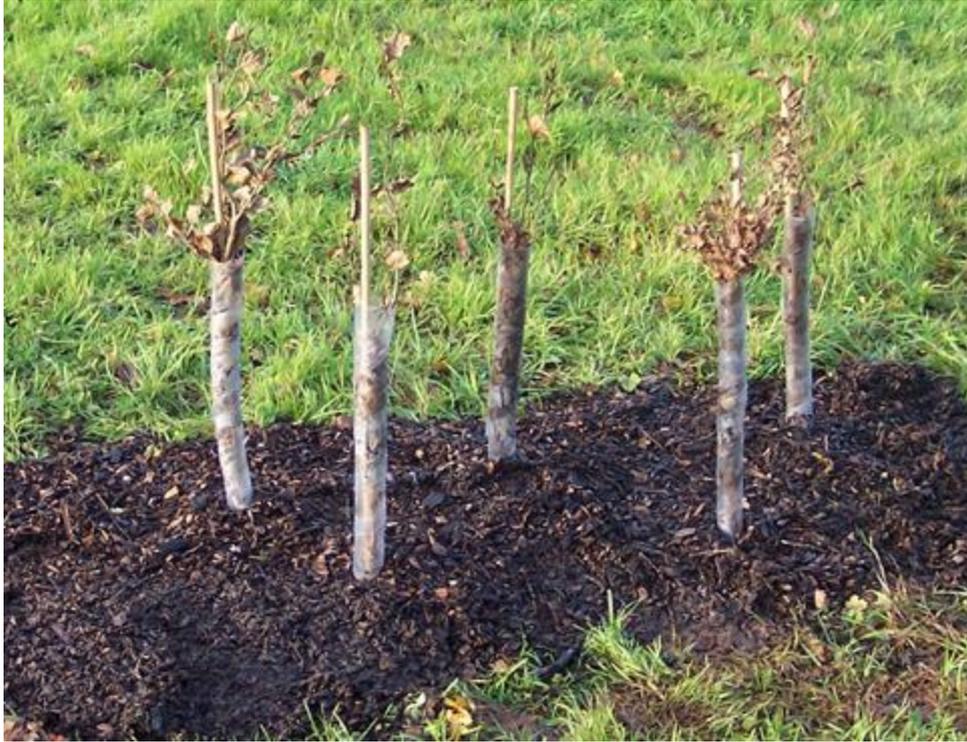
Figure 8b. Row spacing for planting hedgerow whips

When planting whips, position in 2 rows spaced 30cm apart, staggered at 50cm (see Figure 8b, overleaf). Monitor newly planted areas of hedgerow for the first five years, replacing new shrubs or trees which have died, been damaged or become diseased.

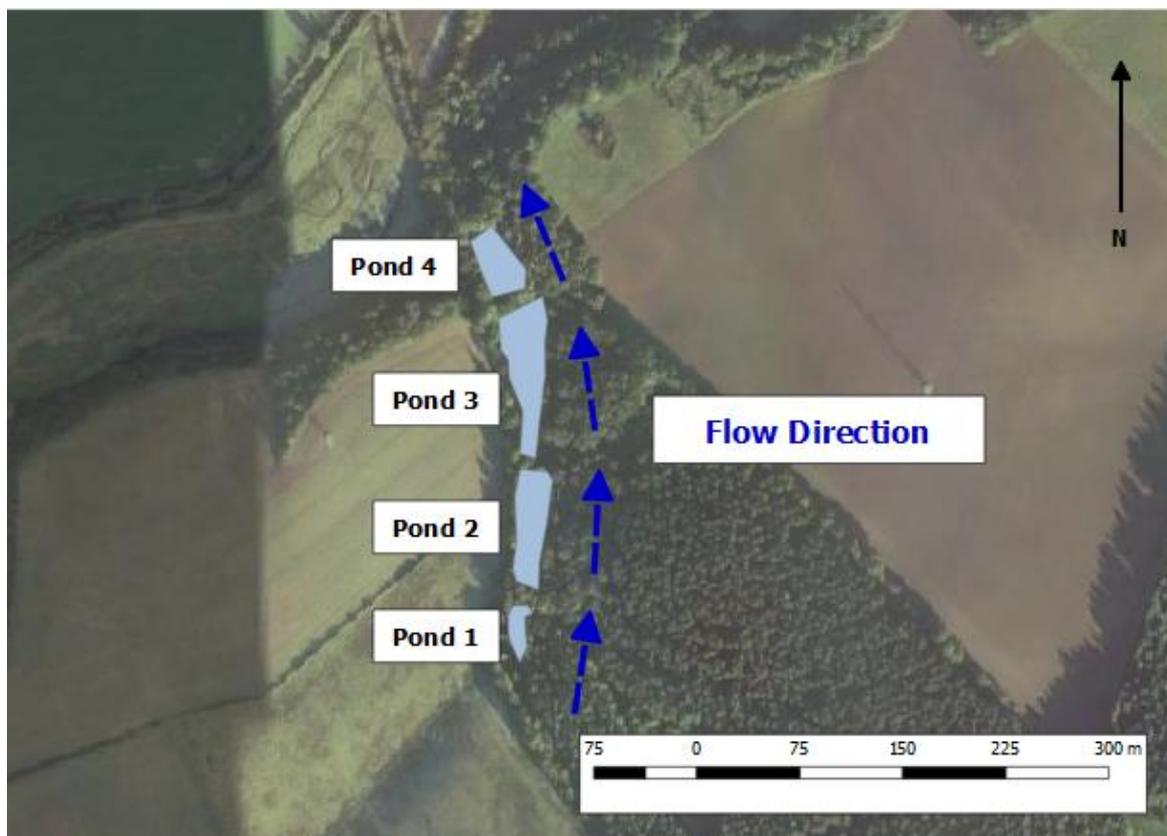
Figure 9. Pond water flow direction

Objectives are to sustain 5,480m² of freshwater ponds for biodiversity. Four freshwater ponds are restored on different levels and gravity fed, descending towards the River Maun as highlighted in Figure 9. Water gradually flows through each pond replenishing the oxygen and preventing flooding.

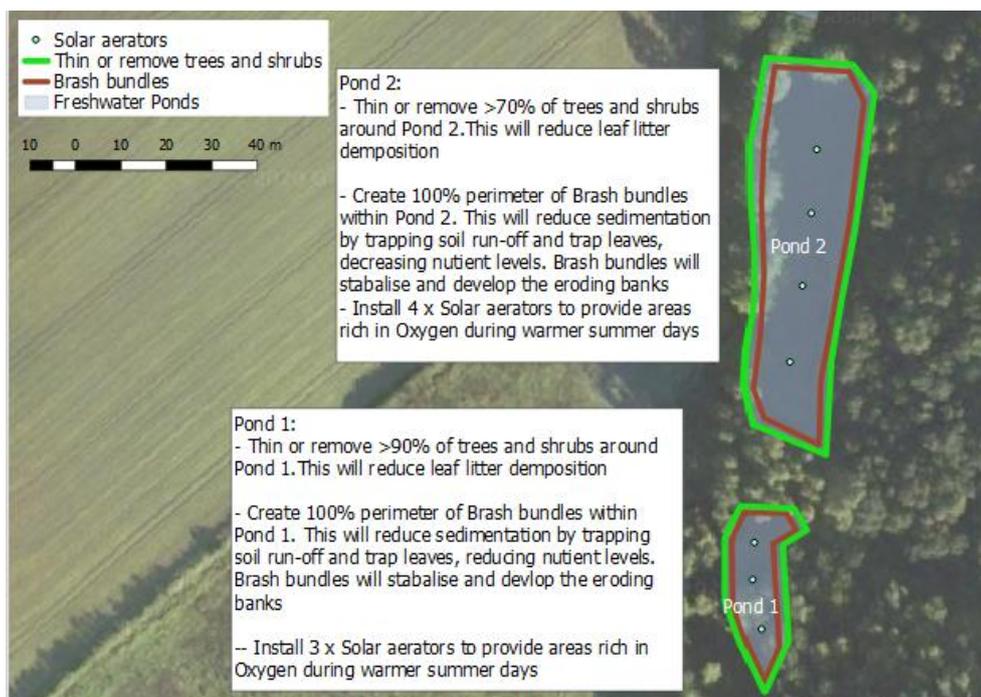
Figure 10. Prescriptions for Ponds 1 & 2

Continued water quality testing recorded a Mean pH 7.71, with the highest pH 9 on 20th March 2019. Increased pH and ammonia events in Ponds 1 & 2 in 2019 need further investigation. Leaf litter and bank erosion are a management issue and revetment work to stabilise the banks and prevent excess sediment entering Pond 2 should be a priority during years 1-5 (see Figure 10, below).

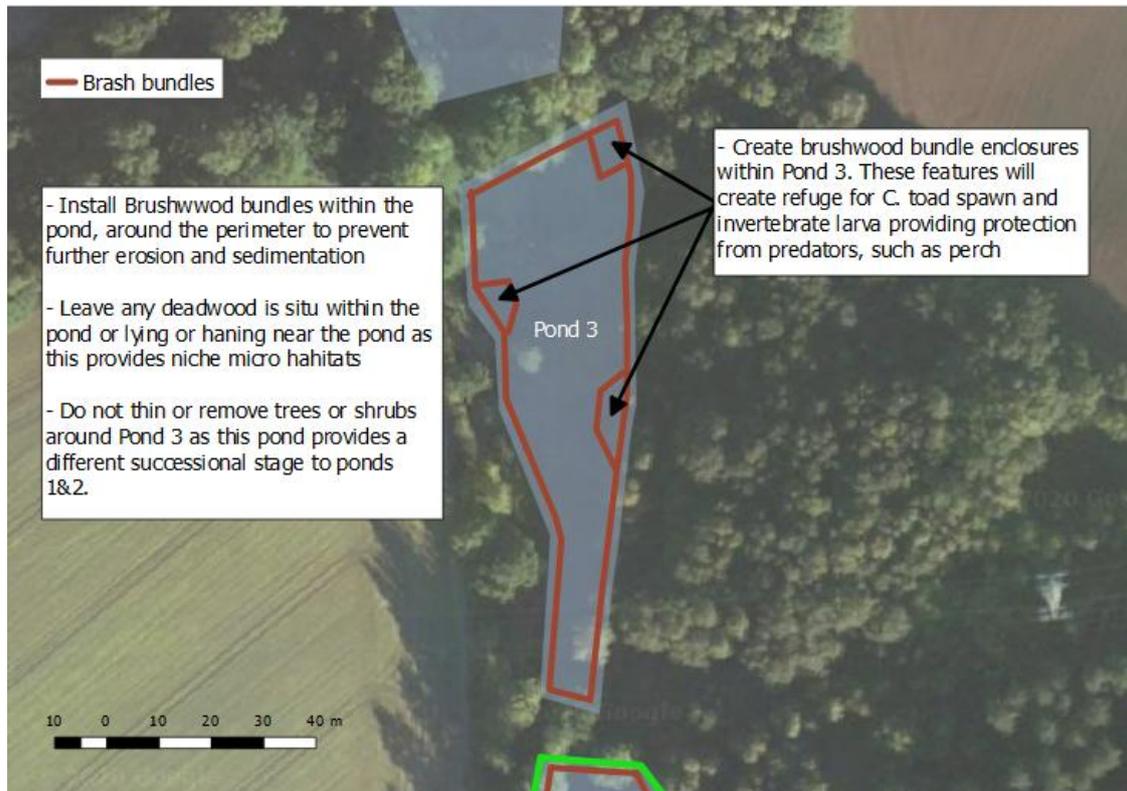
Figure 11. Prescription for Pond 3

Pond 3: *B. pendula* Silver birch and *A. glutinosa* alder trees surround the banks around the pond perimeter. Ground flora is predominantly *R. fruticosus* bramble, *Festuca rubra* red fescue. Water is clear and minimal vegetation grows within the pond apart from sparse areas of *Iris pseudacorus* yellow flag iris. A population of *Perca fluviatilis* perch reside in Pond 3, introduced by local fisherman. To improve aquatic invertebrate and *Bufo bufo* common toad populations, areas of cover and protection need creating using woody debris, highlighted in Figure 11, below. The outflow pipe runs underneath the footpath in the north-west corner of the pond.

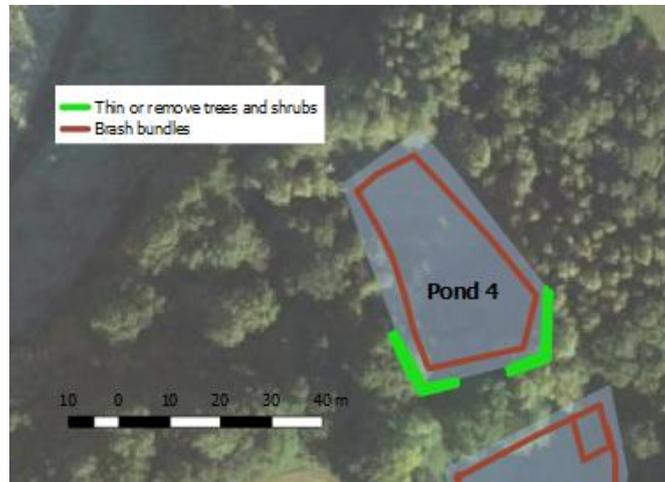
Figure 12. Prescription for Pond 4

Pond 4: Trees surrounding the pond are predominantly *B. pendula* silver birch with *R. fruticosus* bramble and *F. rubra* red fescue for ground flora. Continued water quality testing recorded a Mean pH 7.64. Leave the two islands as unmanaged, non-interventional features. Pond 4 management requires tree and shrub thinning in areas highlighted in Figure 12. The banks need stabilising using woody debris materials (see Figure 13, below).

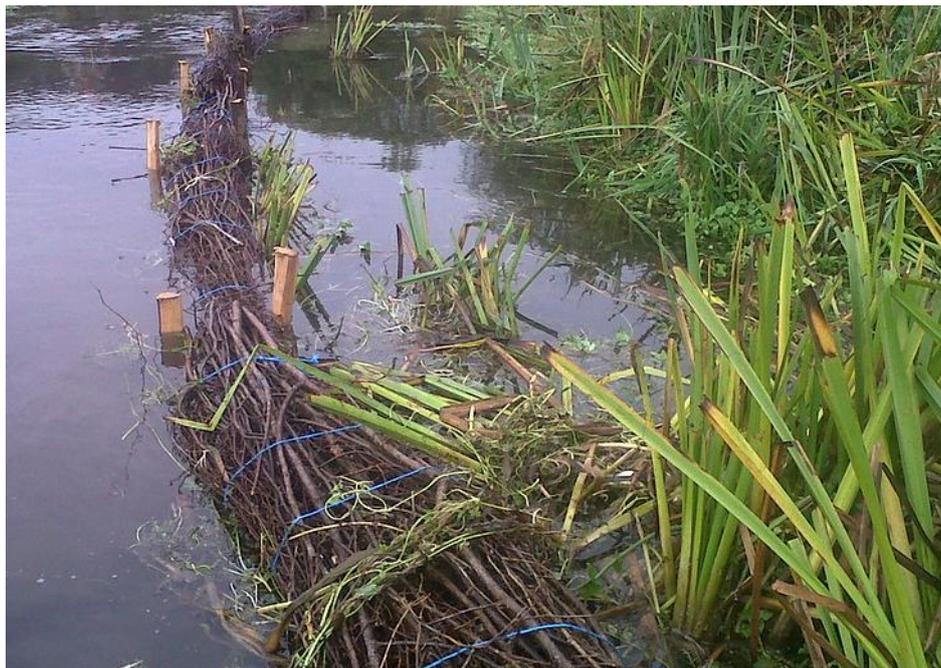
Figure 13. Example of brushwood bundle used to prevent bank erosion

All the ponds would benefit from brushwood bundles pegged with logs along the entire bankside, demonstrated in Figure 13. This will prevent further erosion, sedimentation and over time establish and develop more stable banks and marginal vegetation, whilst improving water quality.

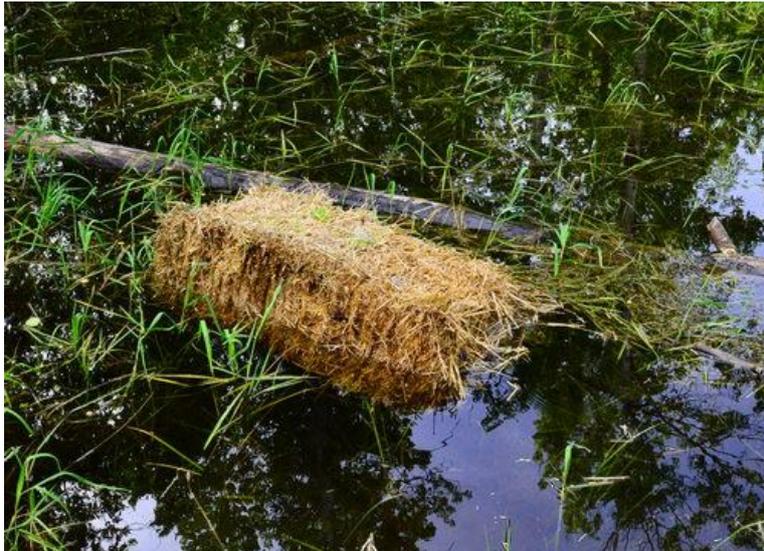
Figure 14. Example of a straw bale used to improve water quality by removing nutrients

The introduction of straw bales in Ponds 1 and 2, positioned at the northern end would improve water quality by removing nutrients (See Figure 14, overleaf).

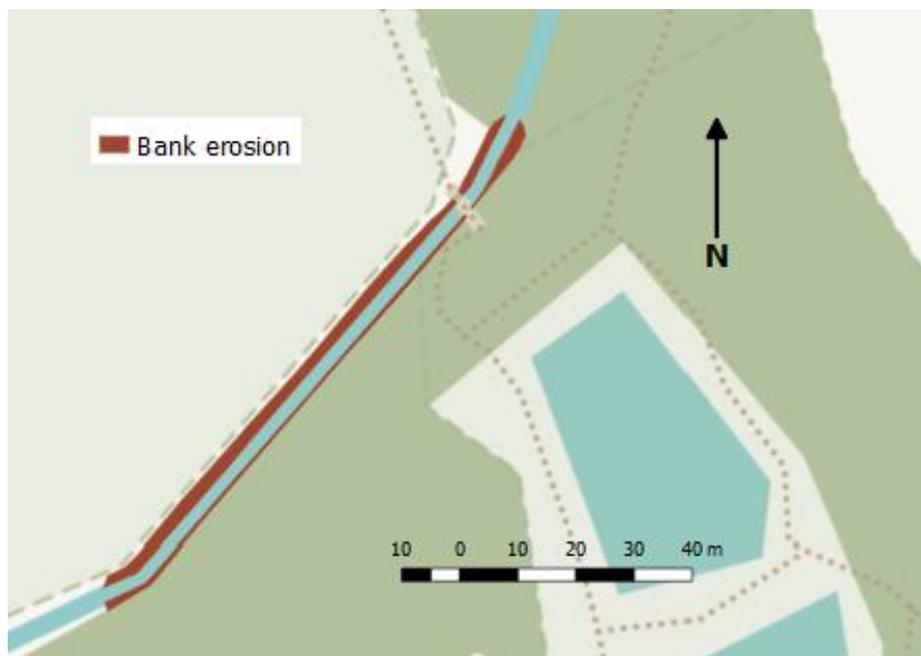
Figure 15. Bank erosion near Spa Ponds along the River Maun

River habitat management objectives are to rehabilitate 25m – 108m of river functions, improve habitat diversity and augment the self-cleansing processes of the channel. This will include introducing woody debris material to narrow the river, create flow variation, rejuvenate spawning gravels and reduce sedimentation of the river bed. Upstream and downstream bank erosion is degrading water quality and the river is widening, and encroaching into the woodland and surrounding agricultural fields, highlighted in Figure 15, below.

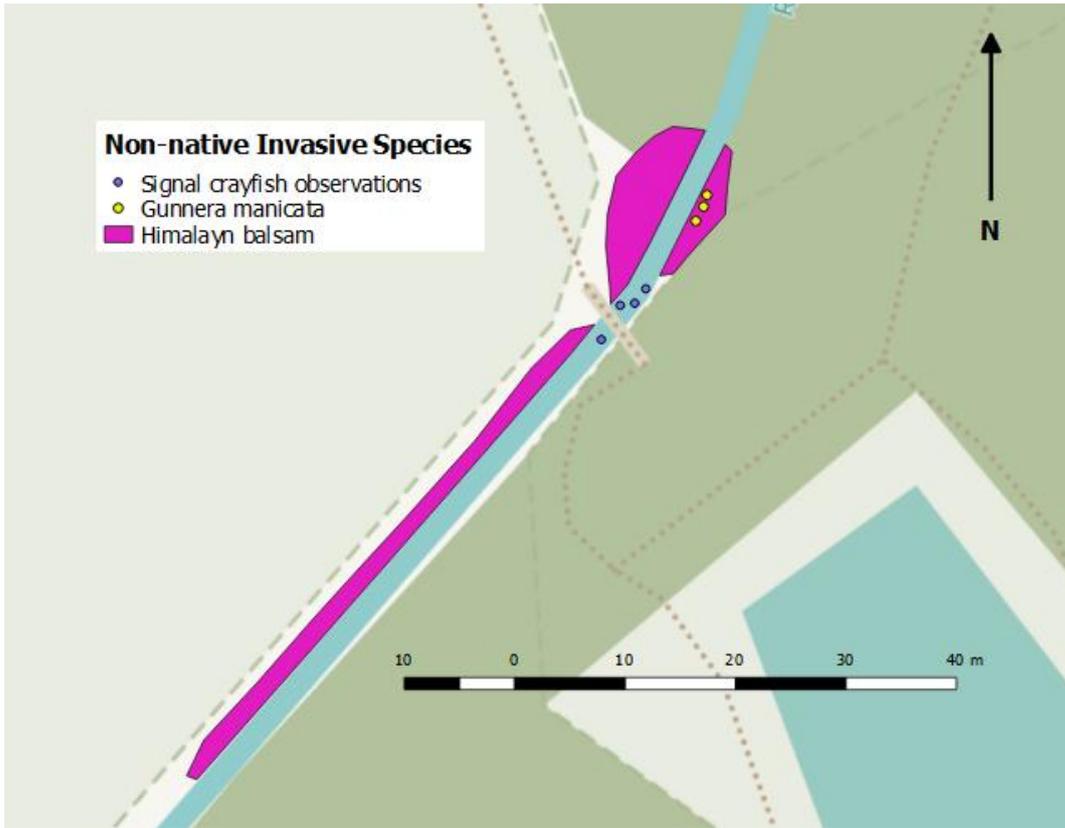
Figure 16. Not-native Invasive Species near Spa Ponds along the River Maun

Bank instability, nitrate and phosphate run-off has created ideal conditions for *I. glandulifera* Himalayan balsam, which dominates swathes along the river, highlighted in Figure 16. Non-native species *Gunnera manicata* is also present (see Figure 16, overleaf).

Pacifastacus leniusculus American signal crayfish are present within this reach and frequently observed near the footbridge (see Figure 16, overleaf). *P. leniusculus* reduce native populations of benthic invertebrates and burrows intensify bank erosion and increase fluvial sediment mobilisation.

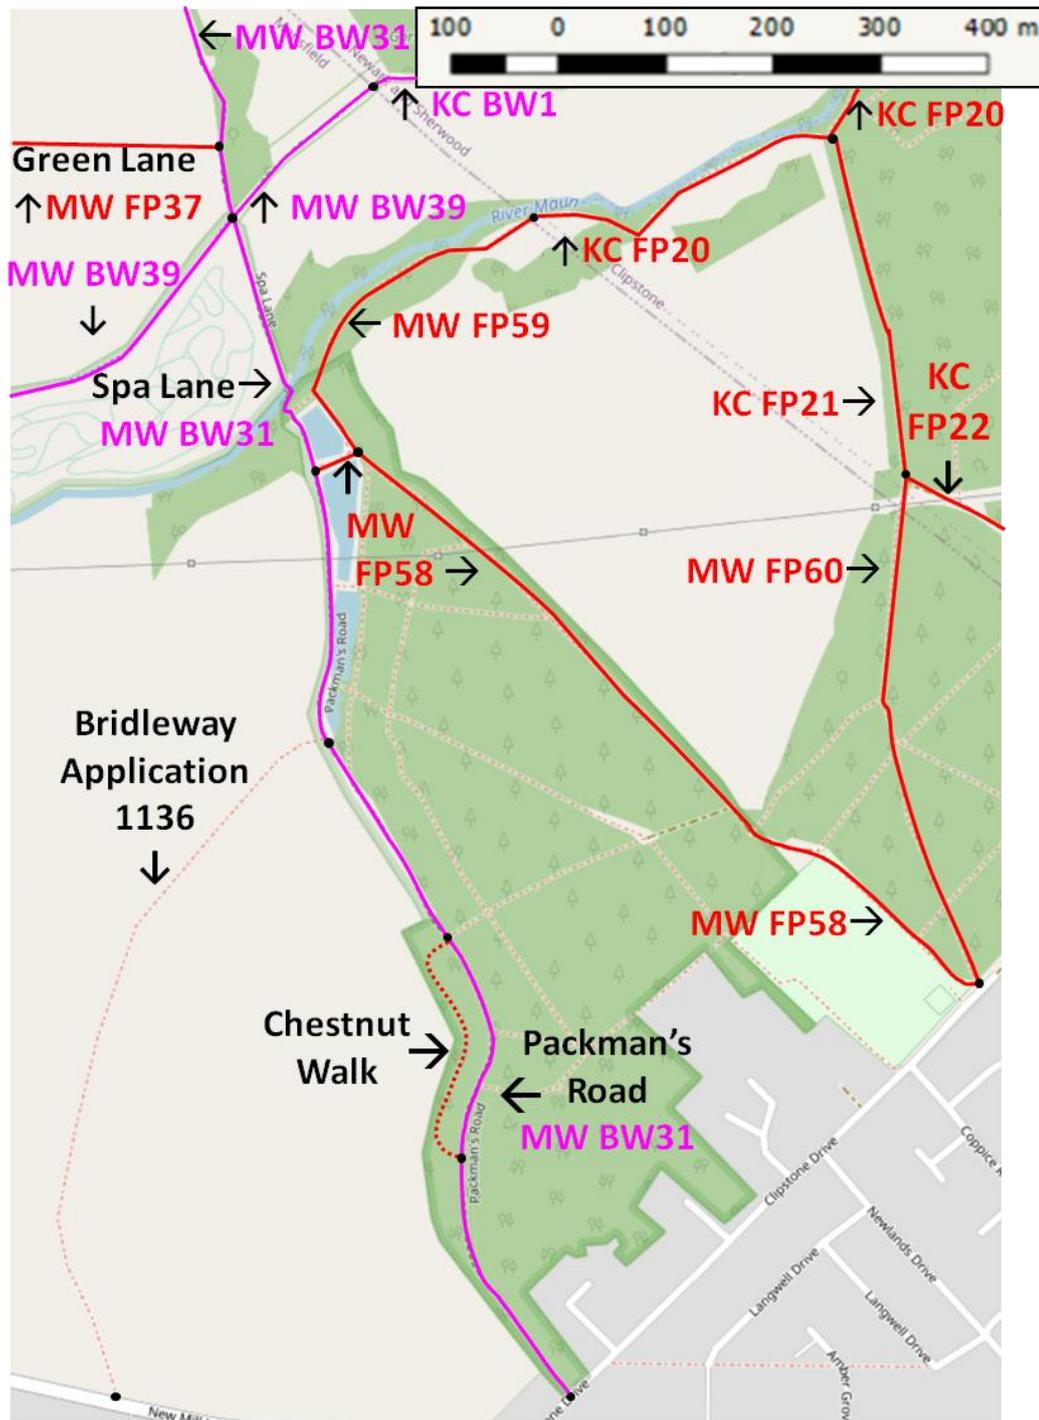
Figure 17. Footpaths and bridleways

FTNCG maintain approximately 3.12 km of Public Right Of Way/Bridle Path and Permissive footpaths, highlighted in Figure 17, below.

Location: MW = Mansfield Woodhouse; KC = King's Clipstone
Path type: BW = Bridleway (fuchsia), FP = Registered Footpath (red),
 Unregistered or Permissive Footpath (red dotted/dashed)
